# **MAKEOVER**

## **Conversion of brick kilns in Delhi-NCR to a cleaner technology**

**A STATUS REPORT**

Centre for Science and Environment

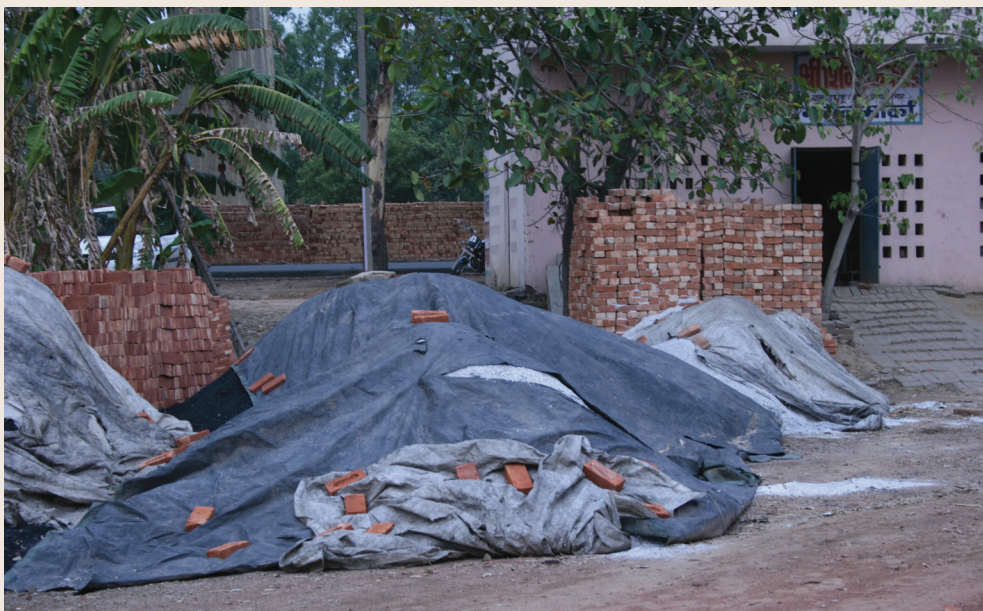
During a survey in Muzaffarnagar, all the kilns were found to have covered their fuel with plastic sheets. One of the kiln owners then informed that a message was circulated among all the entrepreneurs informing them about the survey. The plastic sheets were placed in order to hide the hazardous fuel they were using rather than acting as a preventive method to control the emission.

**Plastic sheets used for covering hazardous fuel**

- SPCBs to work jointly with other government departments and local NGOs to stop the usage of hazardous fuels
  - Enforcing construction of platform and approach ladder to reach porthole at chimney, to facilitate stack emission monitoring

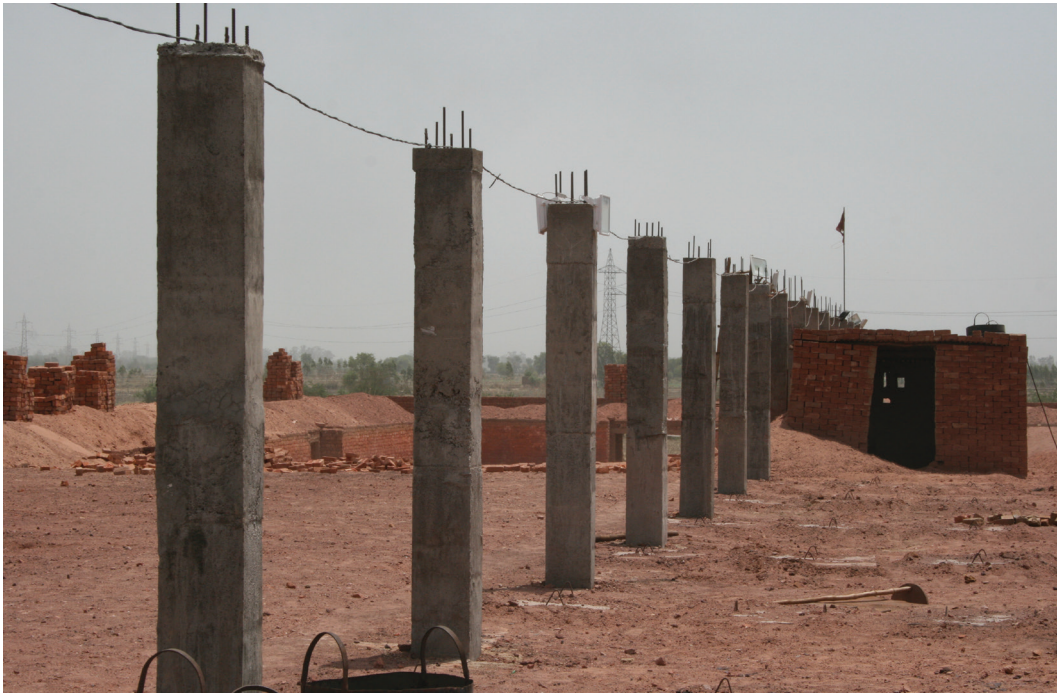
Out of all the surveyed kilns, none had the shed. At the Gopal Brick Field in Rohtak, Haryana, a kiln had a few standing pillars. On further inquiry it was found that construction of a shed has been planned and will most probably be completed before next operating season.

**Pillars for a shed at Gopal Brick Field in Rohtak, Haryana**

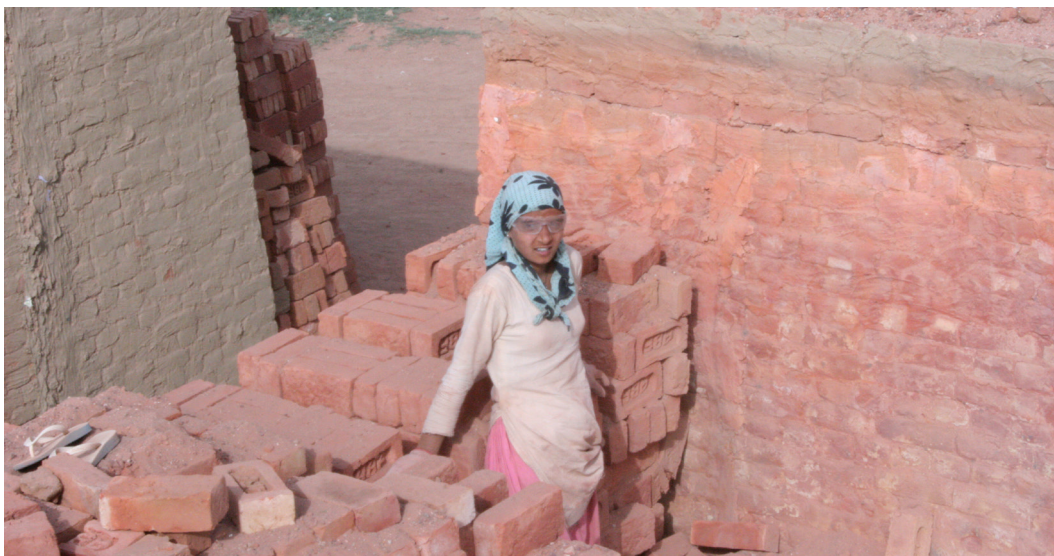
**A worker with protective eye-wear at Arush Brick Field in Gautambudh Nagar, Uttar Pradesh**

is a must for the workers working under such adverse condition — was not observed even at a single site. Out of all the surveyed kilns, only one site, the Arush Brick Field in Gautambudh Nagar, Uttar Pradesh, was found to be providing protective eyewear to the workers.
